Composite Failure Analysis Handbook Update #1

Boeing Defense & Space Group

April 1995

Final Report for the Period Aug 90 - Apr 95

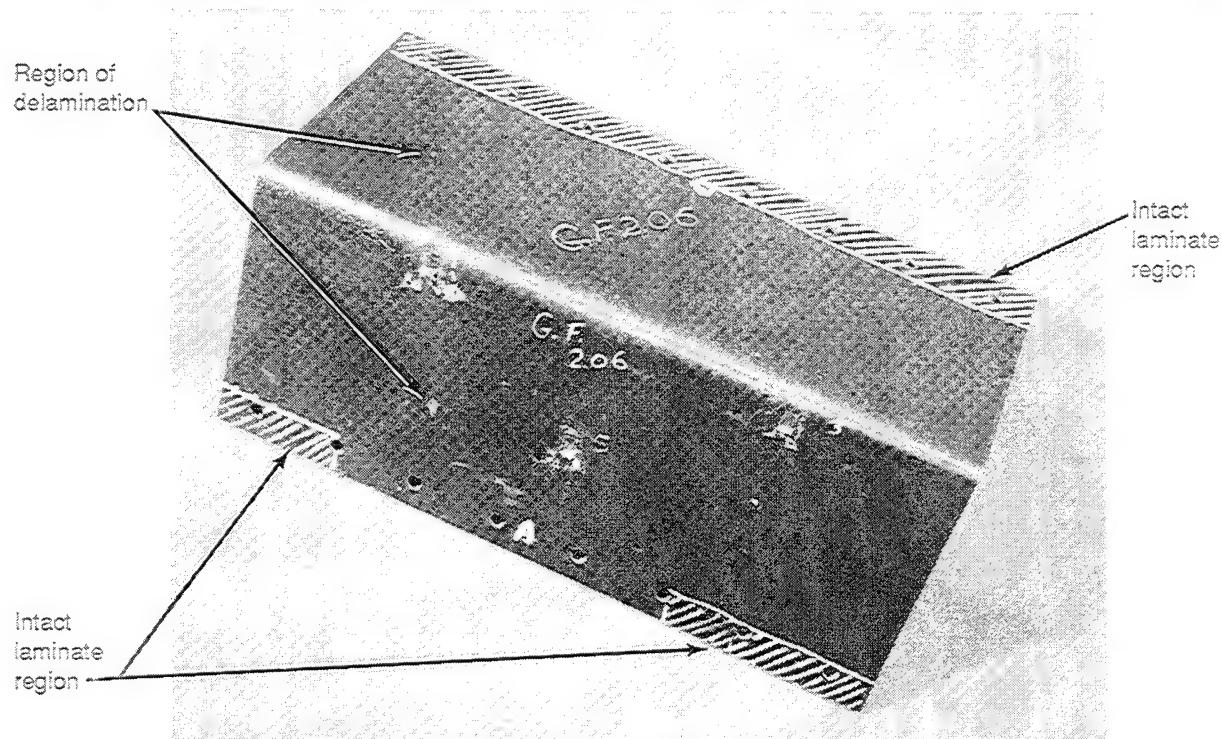
Examination using a handheld pulse-echo unit (C-scan) with a .25-inch transducer identified delaminations throughout the component (see fig. 7) except at certain locations along the region containing the fastener holes.

Figure 7. Photograph Showing the Regions of Intact Laminates Identified Using Pulse Echo

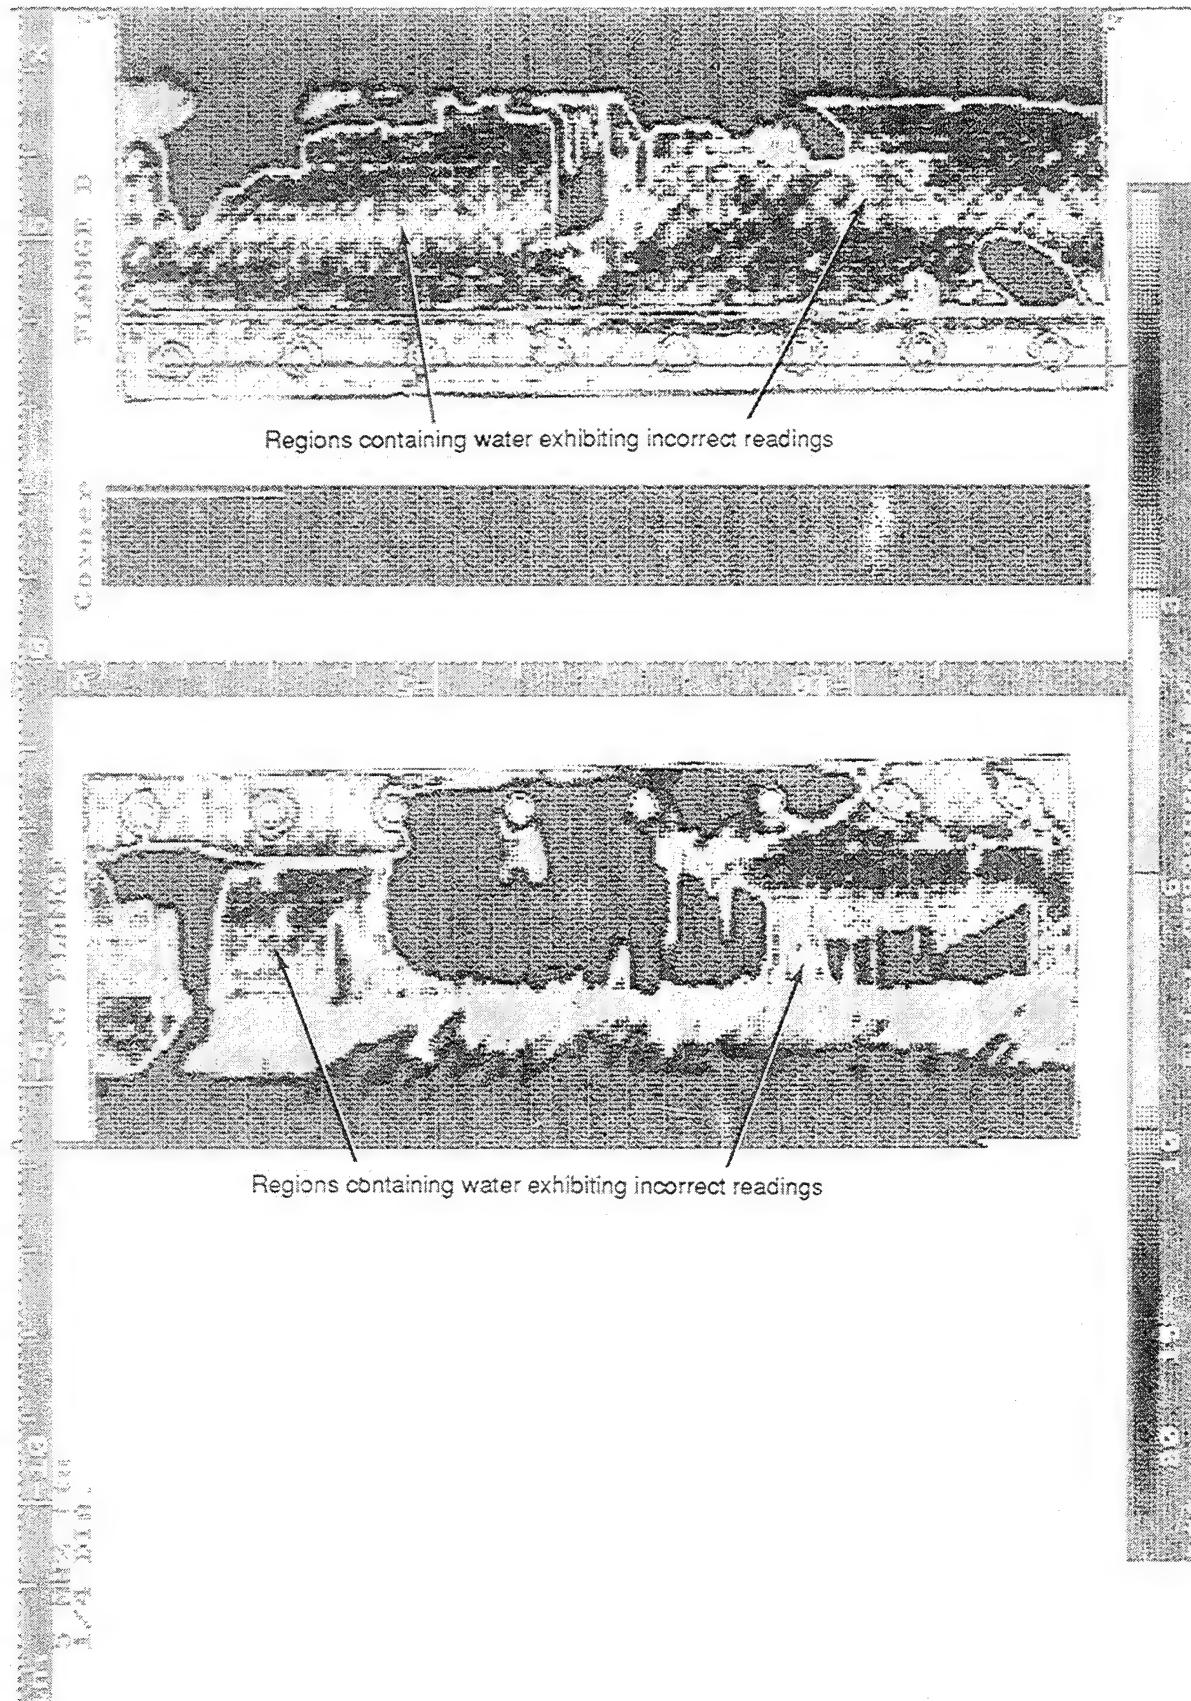
An attempt was made to further characterize the extent of delaminations using TTU (C-scan). However, since the part was exposed to water jets to perform the TTU analysis, large amounts of water entered the part through the edges and caused incorrect indications of delaminations and damage (fig. 8). These were grossly inconsistent with the pulse-echo analysis.

Figure 8. TTU Scan Before Sealing. Water Has Penetrated the Laminates From the Edges Causing Incorrect Readings

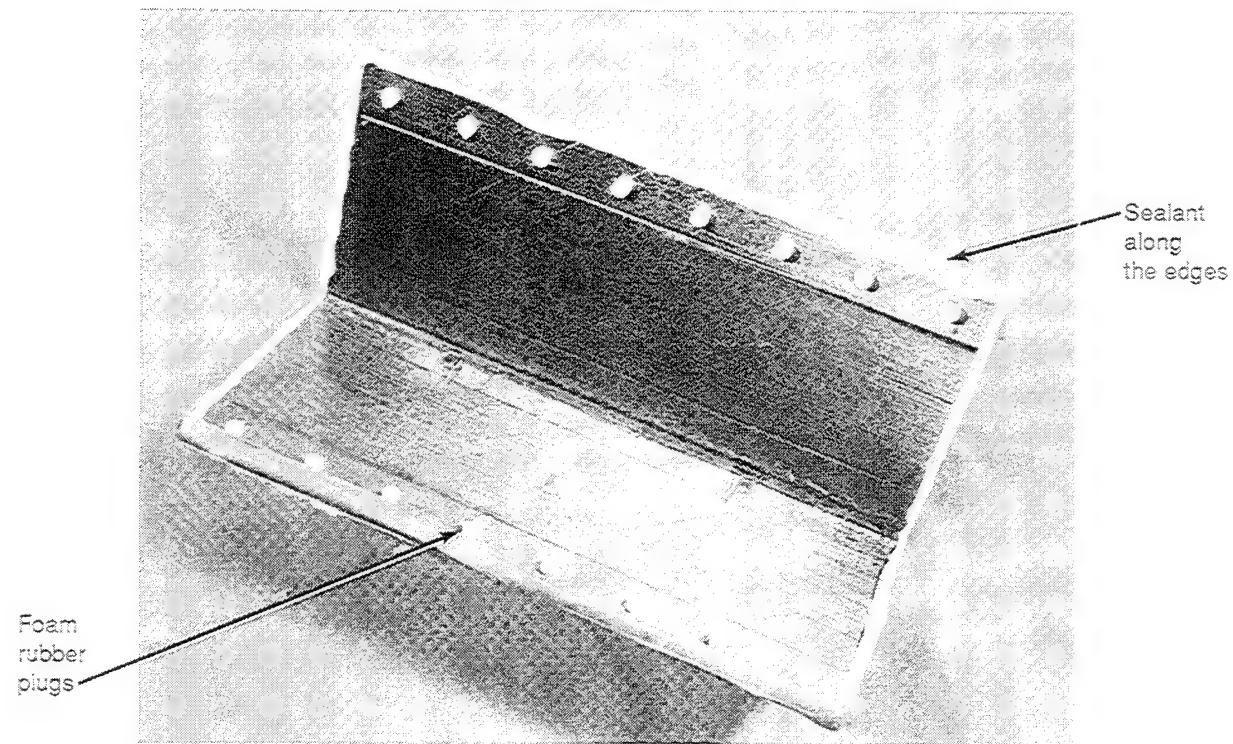
The part was subsequently dried in an oven at 90°F for 30 minutes before another set of scans was performed. This time the edges were sealed, the surface of the part was sprayed with a lacquer, and the fastener holes were plugged (fig 9). The part was then rescanned which revealed that it was almost completely delaminated (fig. 10). The grip areas were not delaminated as observed in the pulse-echo analysis.

Figure 9. Photograph of the Part After the Edges and Fastener Holes Were Sealed Before the Second Series of TTU Scans

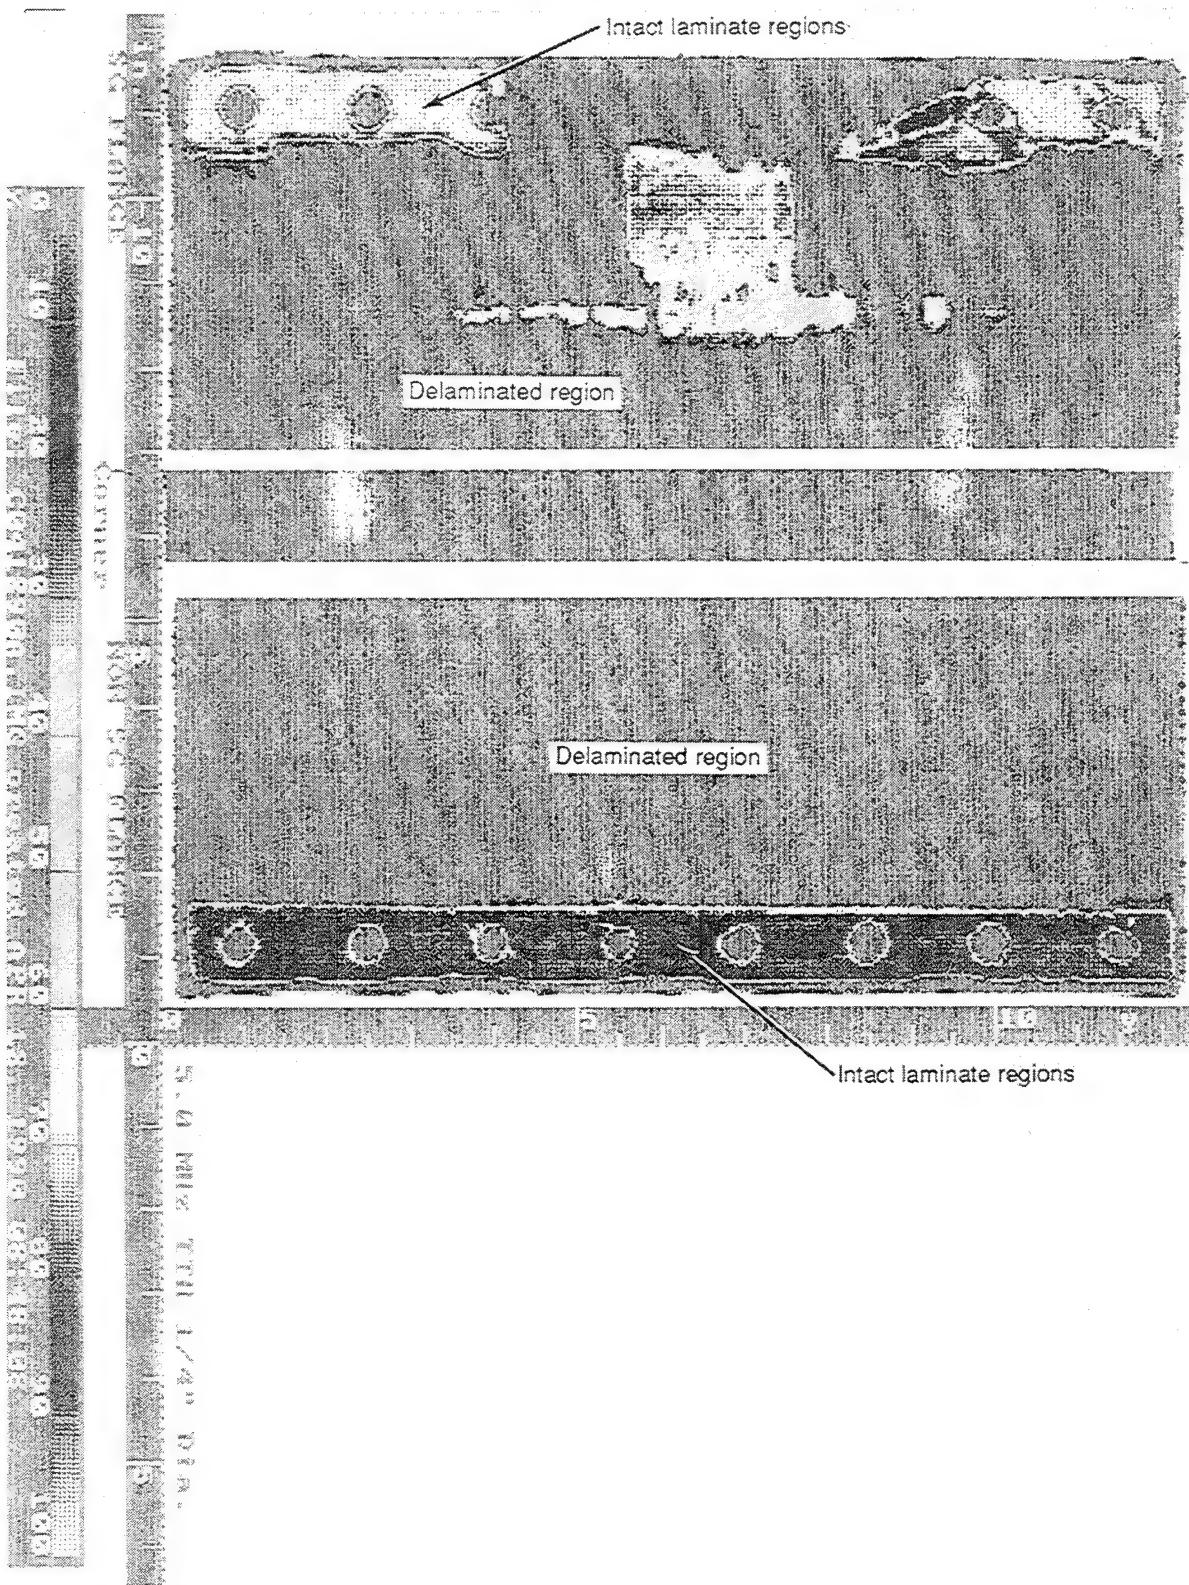
Figure 10. TTU Scan, After Drying and Sealing the Component, Exhibiting Delamination Regions Similar to the Pulse-Echo Examination

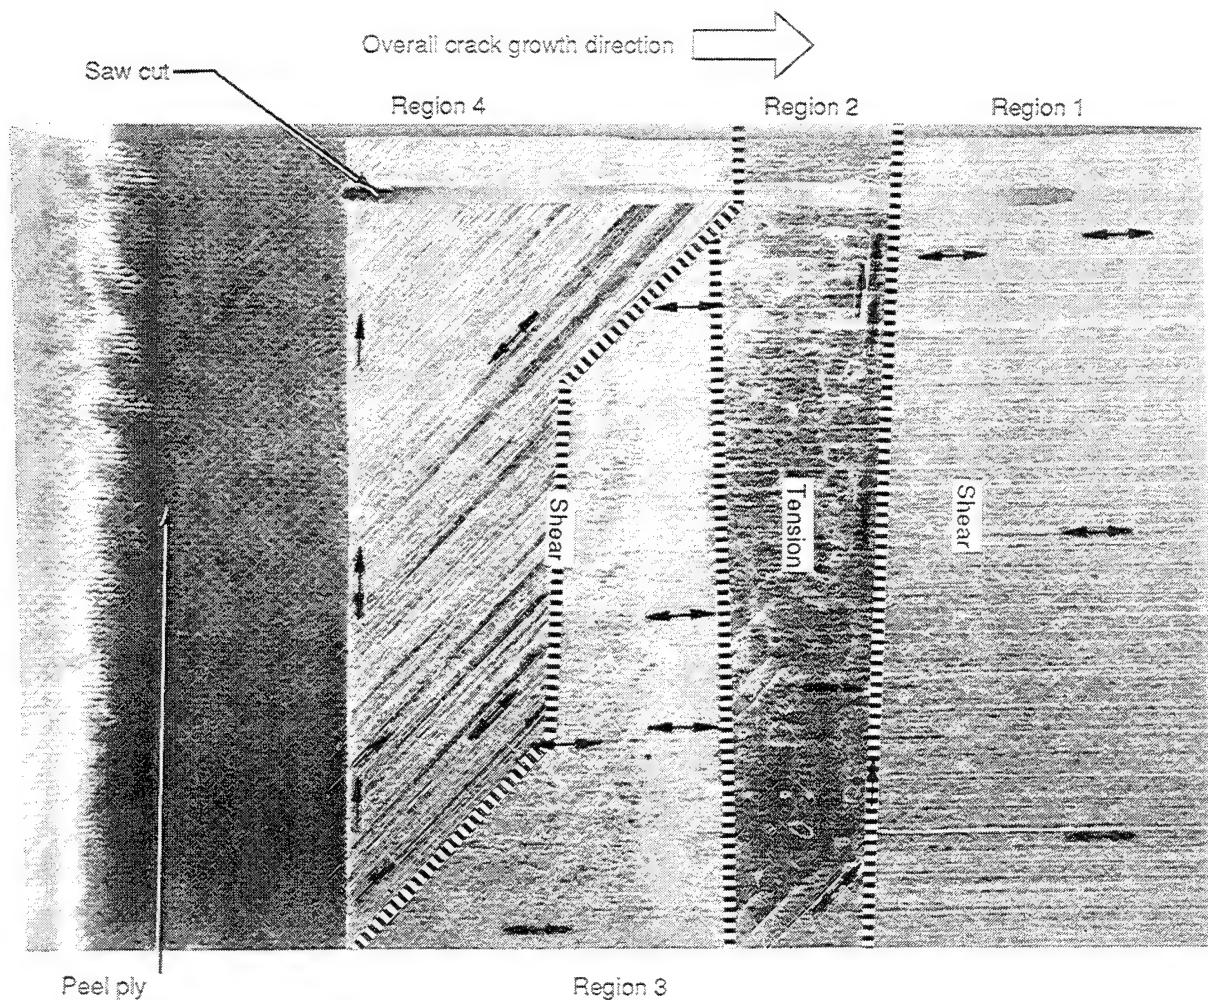
Some fracture surfaces exhibited a change in fracture modes from shearing to a tensile mechanism then back to the shearing mode. As seen in figure 13, the crack initiated at the edge of the peel ply and propagated along the flanges to their edge while changing its crack propagation mode.

Initially, the component was gripped at the edges of the flanges using the fastener holes. As loading began, one edge was pulled away from the other edge which induced an initial shear loading condition inside the component at the edge of the peel ply. The presence of the peel ply in the center (where the maximum shear stress occurred) provided a high stress concentration region which allowed the cracks to initiate. As the edges were pulled further apart, the cracks continued to propagate by shear.

Note: Four regions are identified, exhibiting two different fracture modes:

- Region 1: Mode II (shear)
- Region 2: Mode I (tension)
- Region 3: Mode II (shear) 0-degree fibers
- Region 4: Mode II (shear) 45-degree fibers

Figure 13. SEM Micrograph Showing a Section of the Delaminated Surface Which Initiated at the Peel Ply

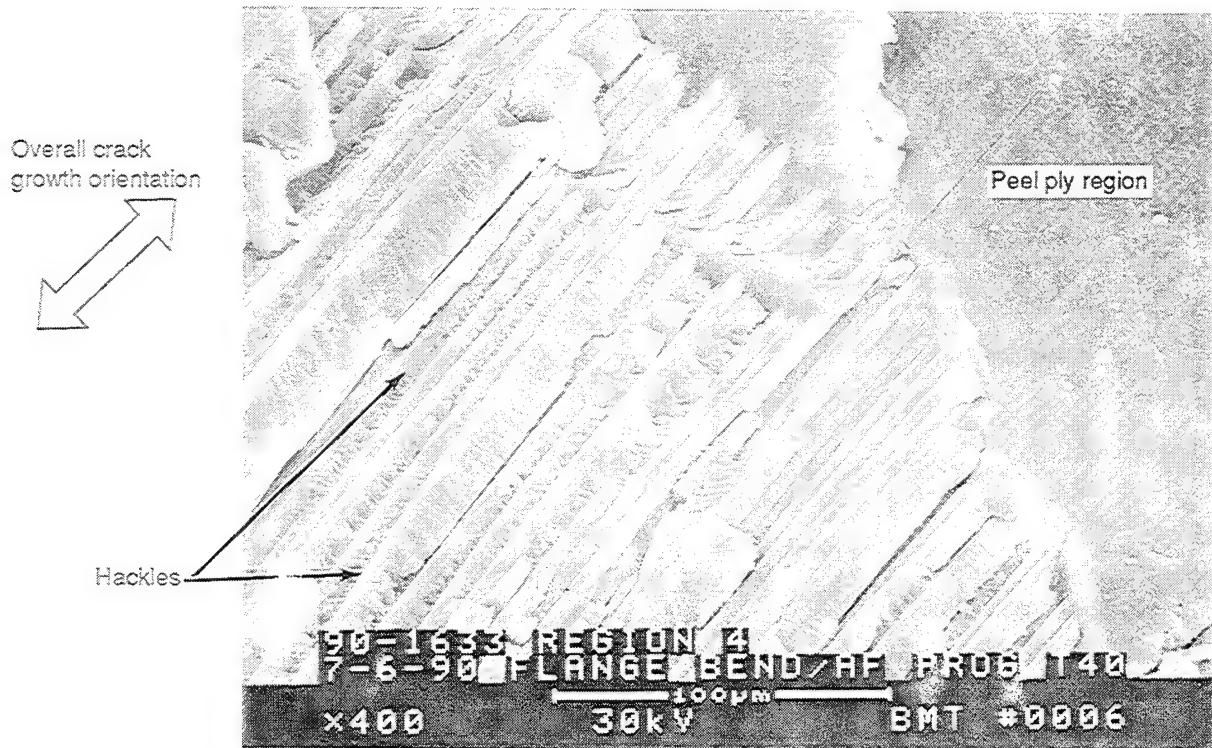
For the one flange, the crack propagated entirely by shear. However, the cracking on the other flange changed modes because the stress orientation had altered significantly enough, due to the component's deformation, to continue the shearing mechanism. As a result, localized buckling occurred which caused a change in the propagation mode from shear to tensile. After further displacement, deformation of the part again changed the loading orientation which changed the propagation mode back to the more energetically favorable shearing mode. Also, the stresses were now sufficient at this point to cause additional delaminations to initiate and propagate in the knee region. This continued until the crack reached the gripped region which was clamped and restricted further crack propagation.

Figure 14. SEM Micrograph of a Mode II-Type (Shear) Fracture Surface in Region 4 adjacent to the Peel Ply

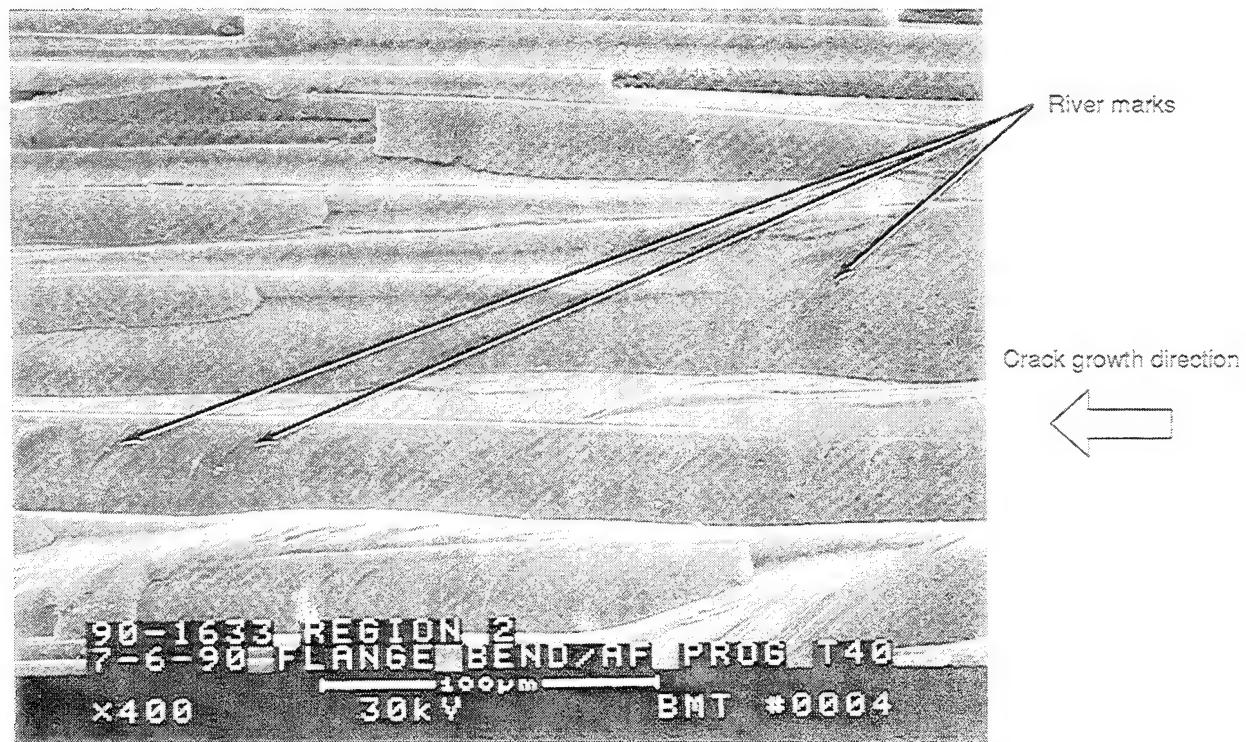
Figure 15. SEM Micrograph of a Mode I-Type (Tension) Fracture Surface in Region 2

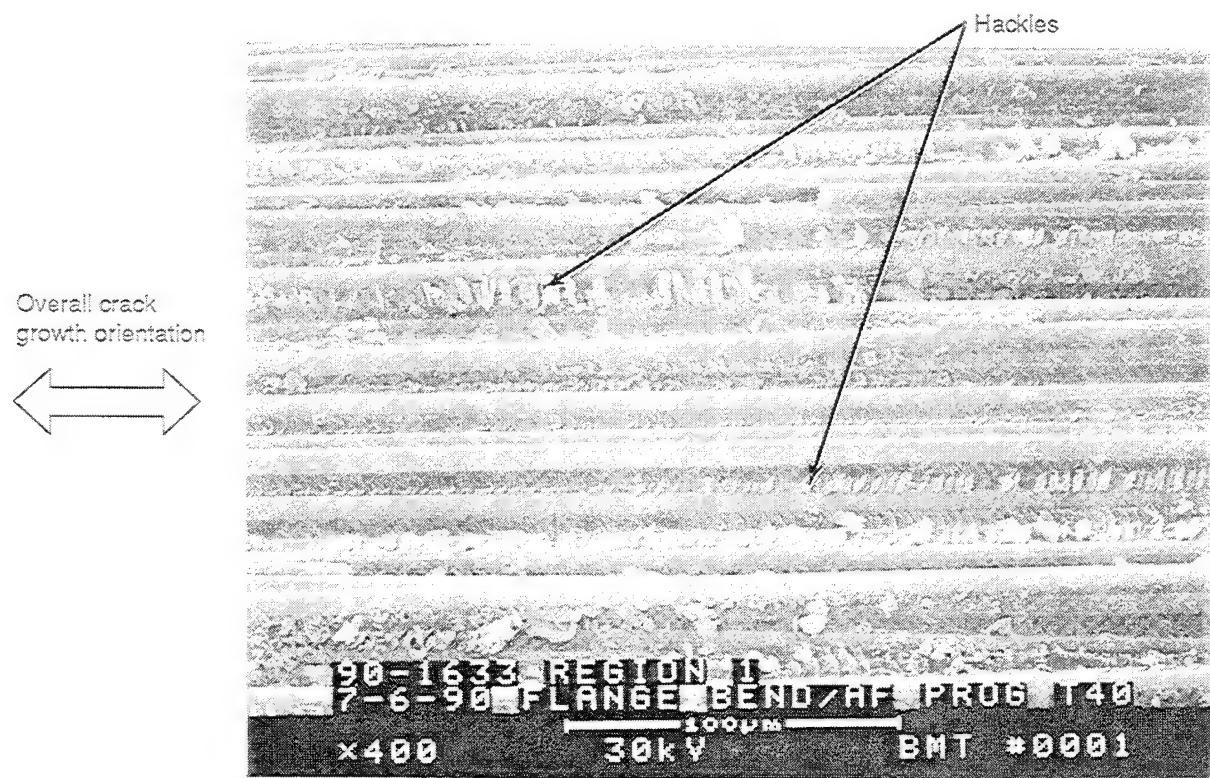
Figure 16. SEM Micrograph of a Mode II-Type (Shear) Fracture Surface in Region 1

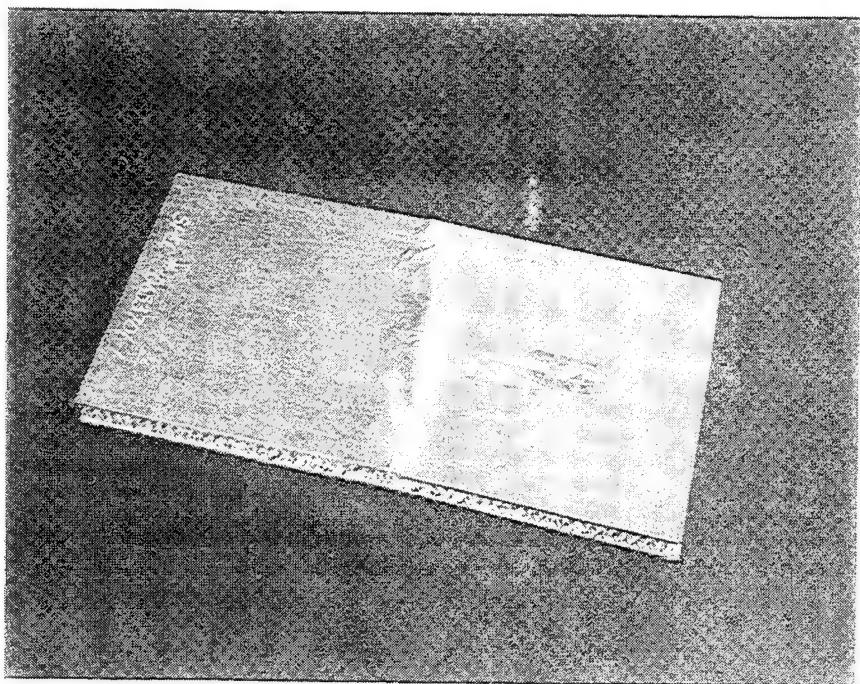
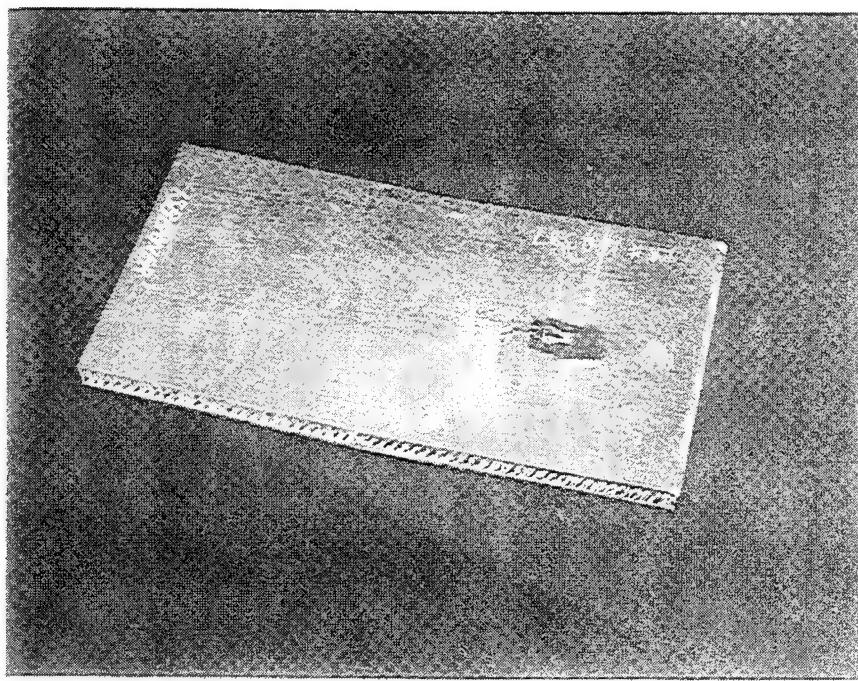
Figure 2. Photographs Showing the Top and Bottom Surfaces of the As-Received Component

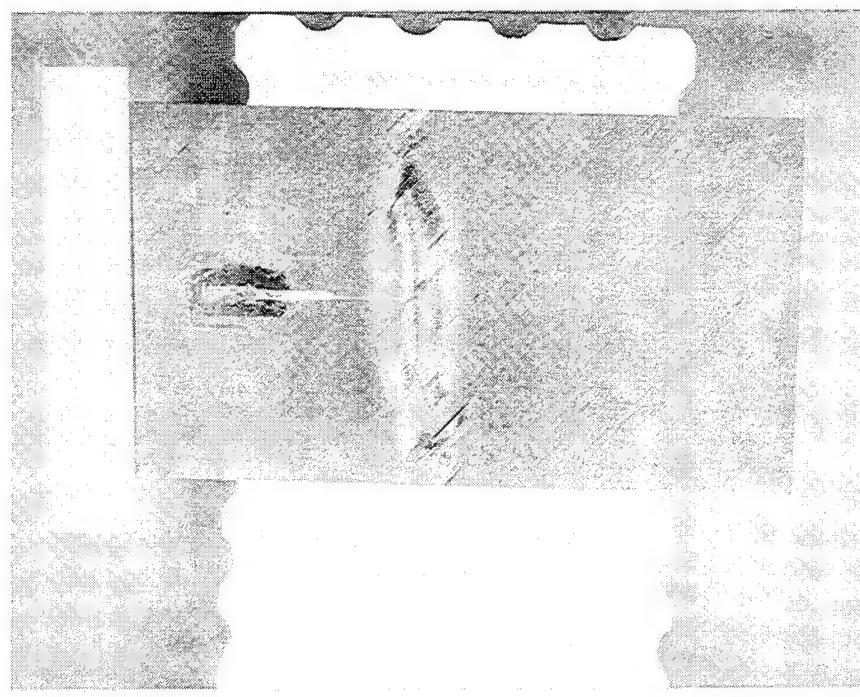
Figure 4. Buckled Surface Showing the Angled Slit Lighting Contours

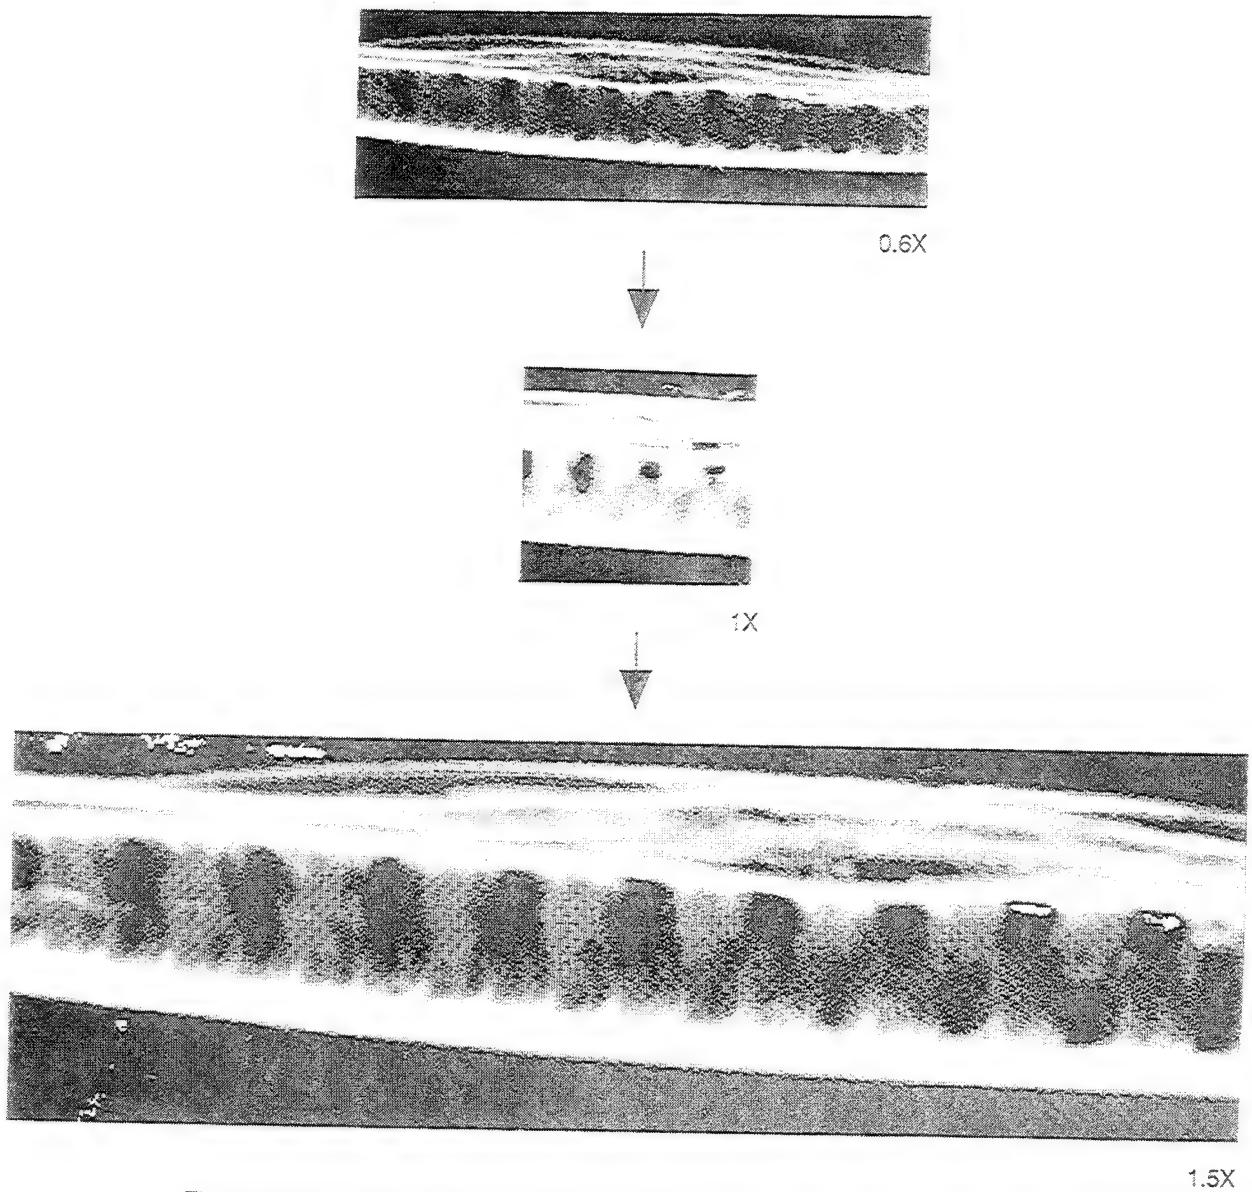
Figure 8. CT Images of the Transverse Scan Through the Delaminated Zone

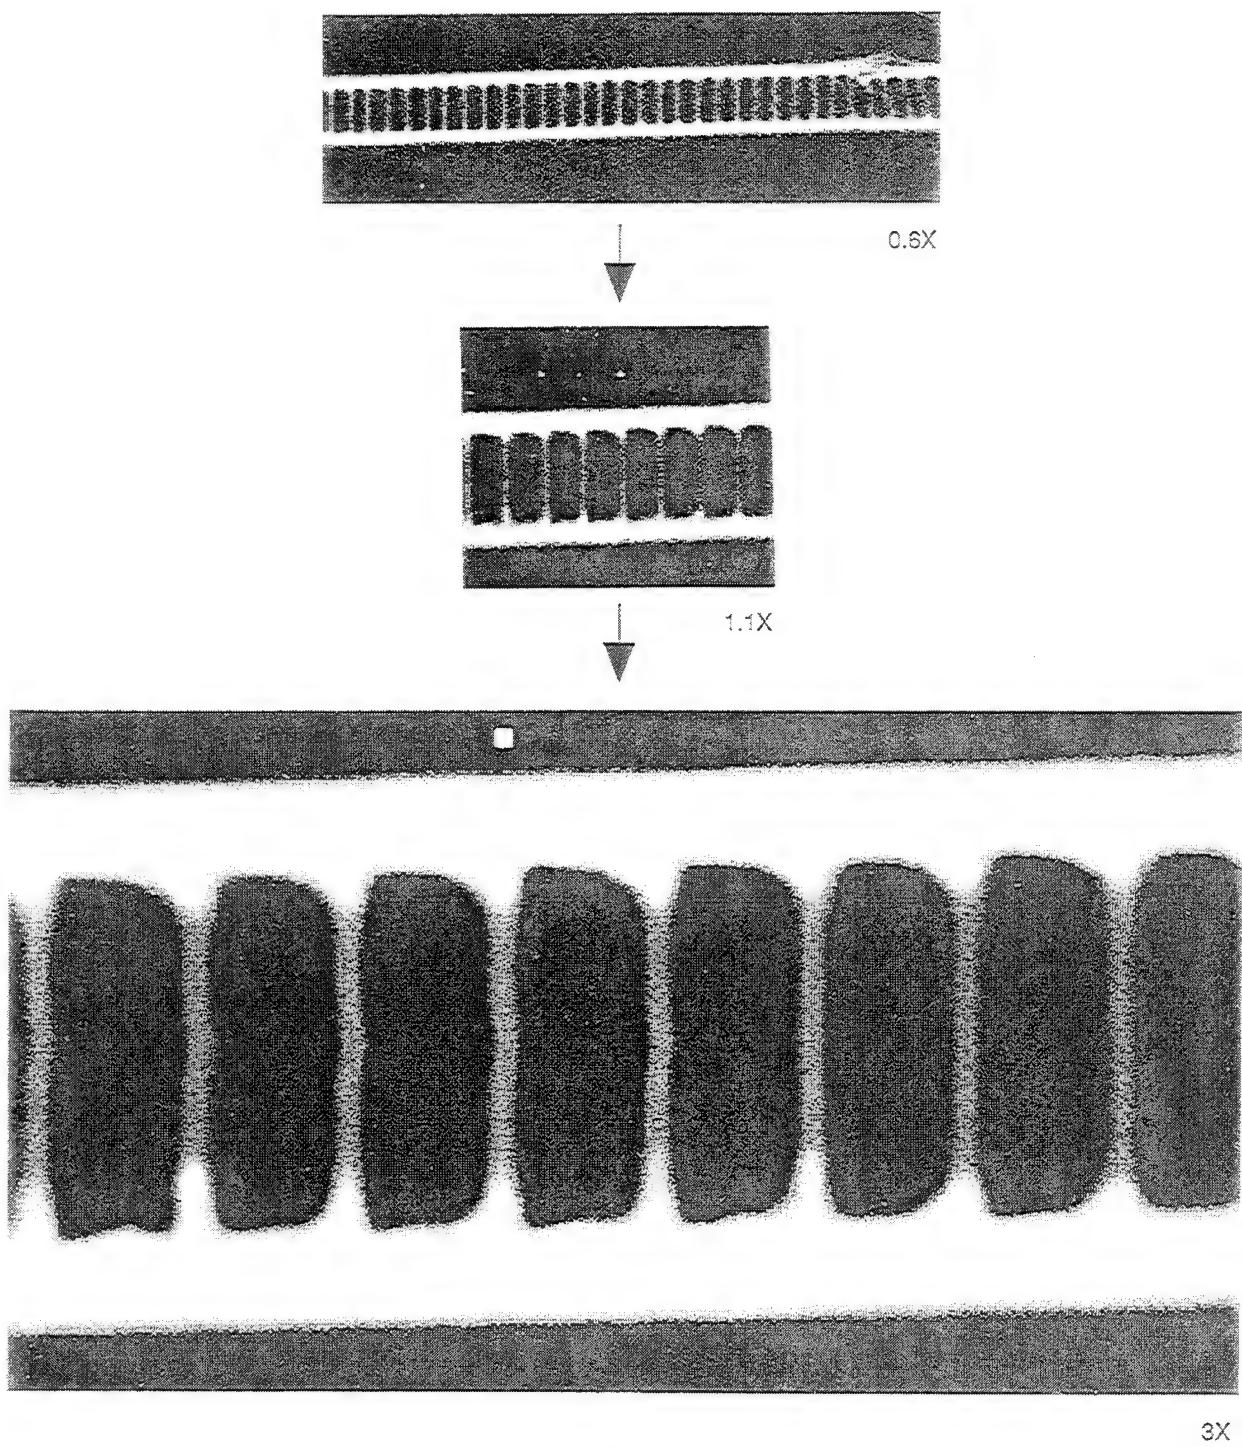
Figures 8 through 11 through show the various images of the slices through the component. The longitudinal slices 1, 2, & 3 show the damage present in the honeycomb regions in the center of the component. The front half of the panel appears to have been crushed by a macroscopic shearing of the upper front half of the facesheet. The back half exhibited little if no damage. However near the bulge, the core appeared to be crushed in the short transverse direction. There was no evidence showing any longitudinal buckling trends to either end (from one end to the other). This transverse damage was located all along the back half of the component.

Figure 9. CT Images of the First Longitudinal Scan

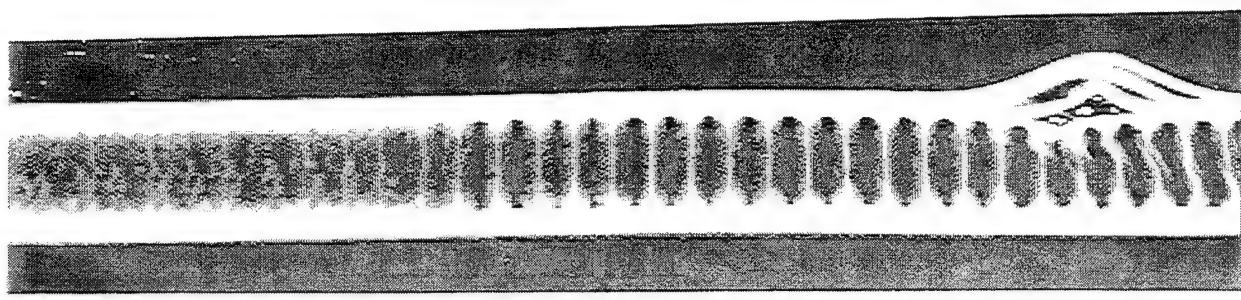
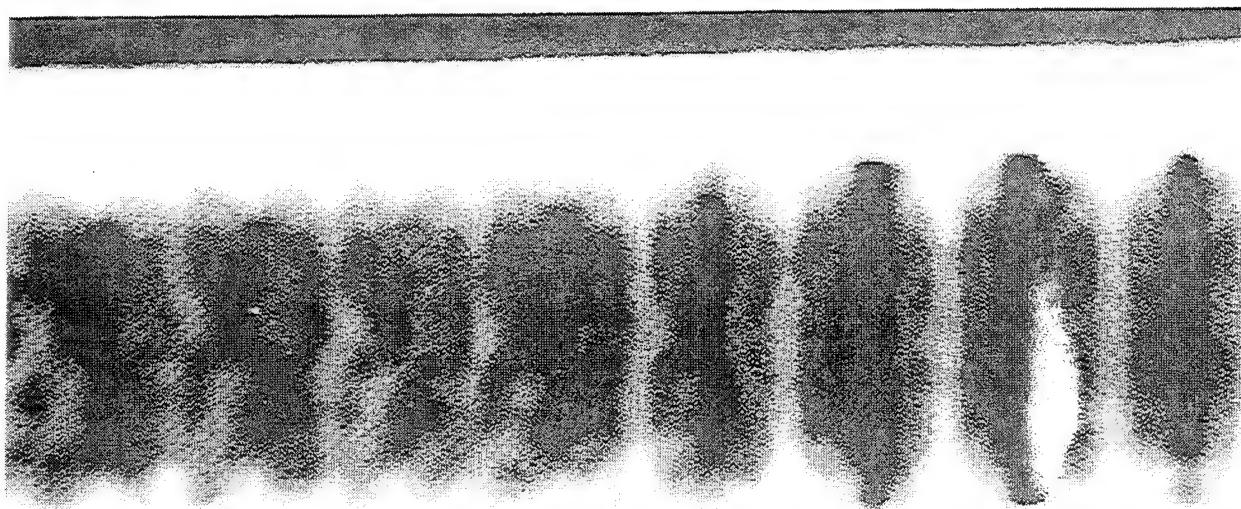
Figure 10. CT Images of the Second Longitudinal Scan

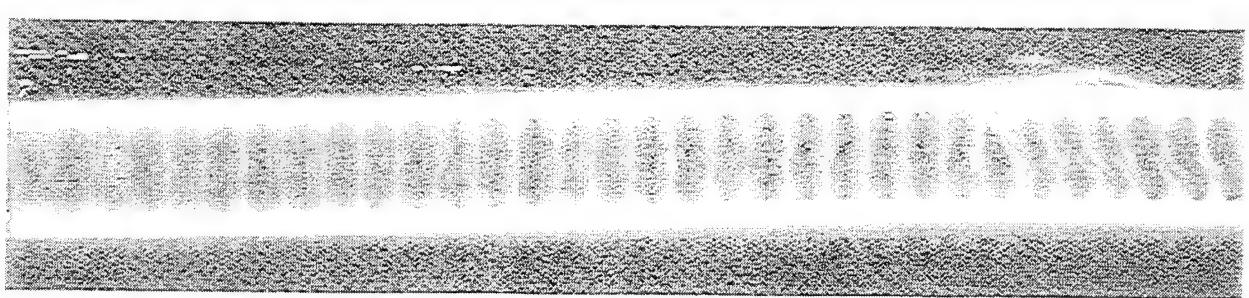
Figure 11. CT Image of the Third Longitudinal Scan

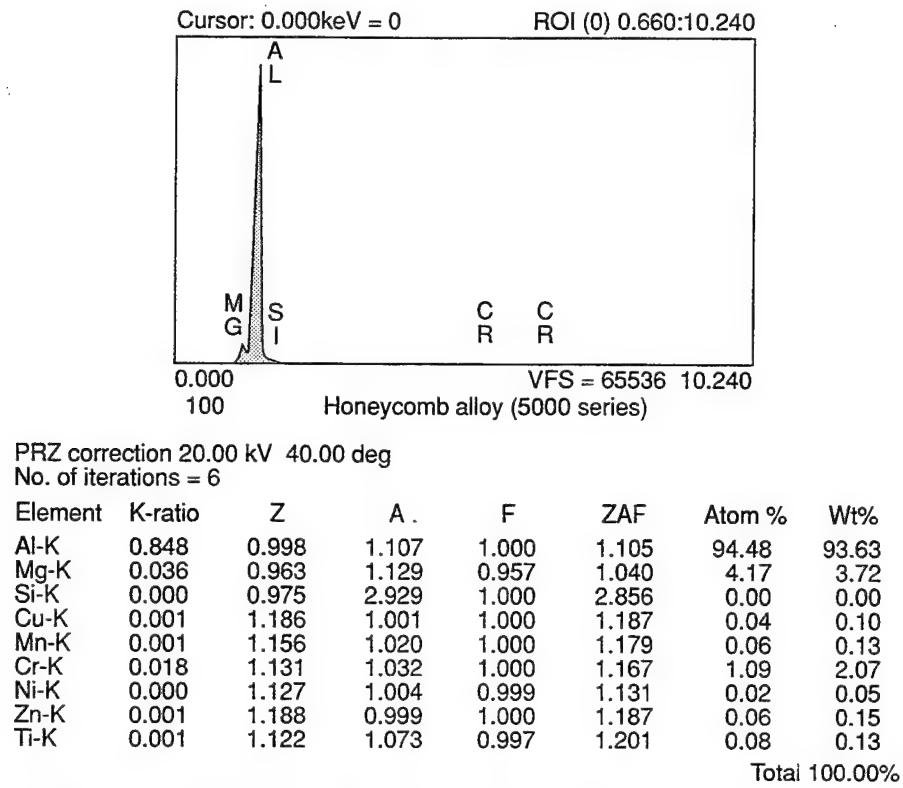
The honeycomb core was composed of a 5000 series aluminum as determined by the EDS analysis (Figure 14). Although aluminum honeycomb cores are usually made from 5000 type alloys, the EDS instrument is not accurate enough to identify the specific alloy in this series.

Figure 14. EDS Spectrum Showing the Major Elements That Have Been Detected and a Semi-quantitative Analysis of the Material

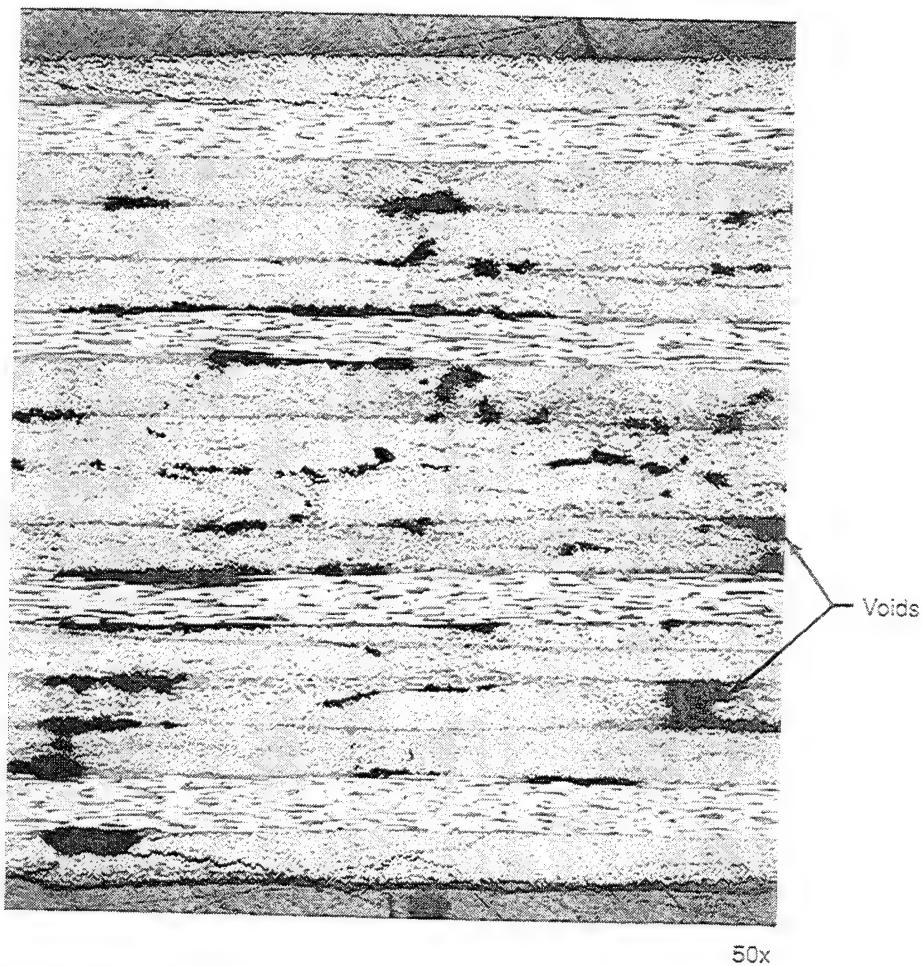
A small section of the panel was cut, mounted, ground and polished. The facesheet ply orientation sequence was: [(+45/90/0/-45)2]s. Major voids were observed throughout the facesheet (see Figure 15). This could be the result of incorrect processing of the composite material prior to assembly of the entire component because the adhesive bond appeared to have been processed correctly.

*Figure 15. Cross-Sectional Micrograph of the CFRP Face Sheets
Showing the Extent of Porosity and the Lay-Up Sequence*

- d. There was a uniform distribution of voids or porosity throughout the CFRP face sheets.
- e. Damage to the honeycomb core was either deformation or fracturing. In both cases, the damage only occurred in the center of the cell walls and not at the core-adhesive region.

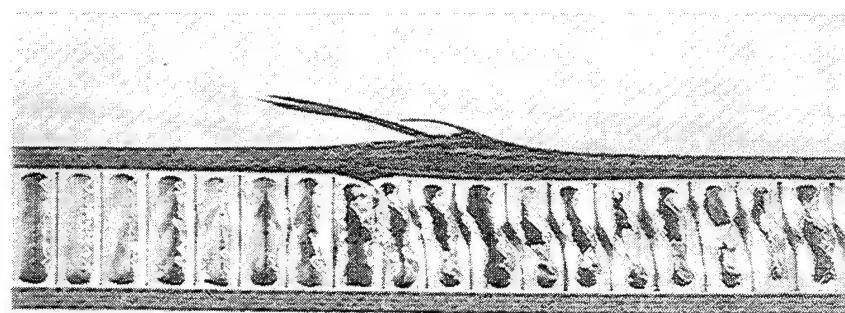
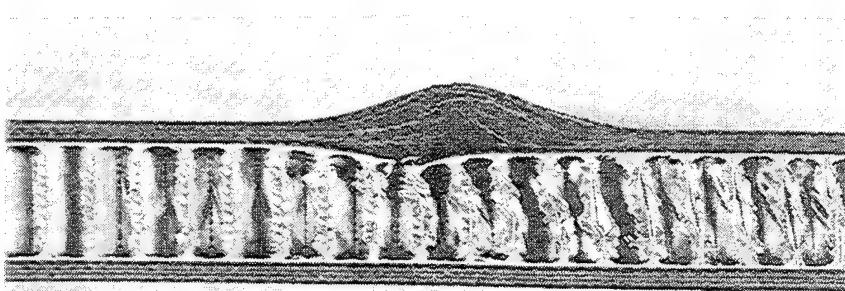
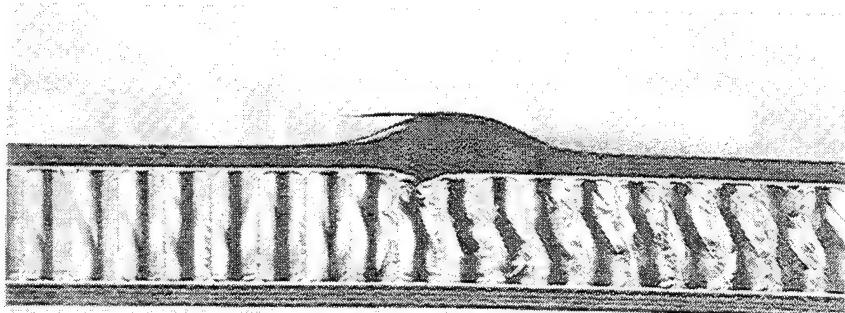
The component was sectioned longitudinally along the same three locations as the CT scan slices to obtain a more detailed examination of the damage within the panel. Figure 16 shows the cross-section at the right edges of each section which correspond to the CT images in Figures 9 to 11. Examination of the surfaces reveal damage similar to the CT images.

Figure 16. Photographs of Cross Sections Through the Panel Corresponding to the CT Scans:

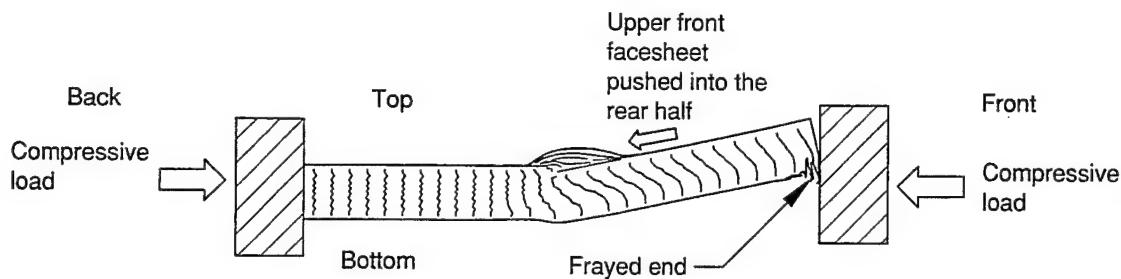
The transverse delamination region of the facesheets is indicative of compressive loading. There are two general ways in which the panel could have been loaded in order to cause a compressive load; the first would be a three point loading configuration; the other would be a simple longitudinal compressive loading applied to the ends of the panel. If the component had been loaded in the three point loading configuration, the bottom side should exhibit tensile cracking and the honeycomb core on either side of the transverse delaminated region would not have been damaged or deformed. However, examination of the internal structure by both the CT scans and the sectioning revealed a non-uniform deformation. The longitudinal compressive loading configuration would most likely have produced this type of damage. Figure 17 shows a diagram of the panel illustrating a plausible loading sequence that could account for the damage to the panel. As the load was applied to both ends of the panel, the top facesheet began to delaminate and eventually buckle. Then the front half of the top facesheet shifted towards the back, deforming the honeycomb core in the process. This in turn caused the panel to bend with the back half of the panel remaining relatively straight while the front half twisted downward which resulted in the edge of the bottom facesheet being frayed. The downward twisting movement also deformed the bottom of the panel.

Figure 17. Diagram Showing the Probable Loading Configuration and Subsequent Deformation of the Panel

- f. Based on the information collected from the examination, the damage most likely occurred as a result of longitudinal compressive loading.
- g. Other than the porosity, no other anomalies were identified that could have caused premature failure or crack initiation.

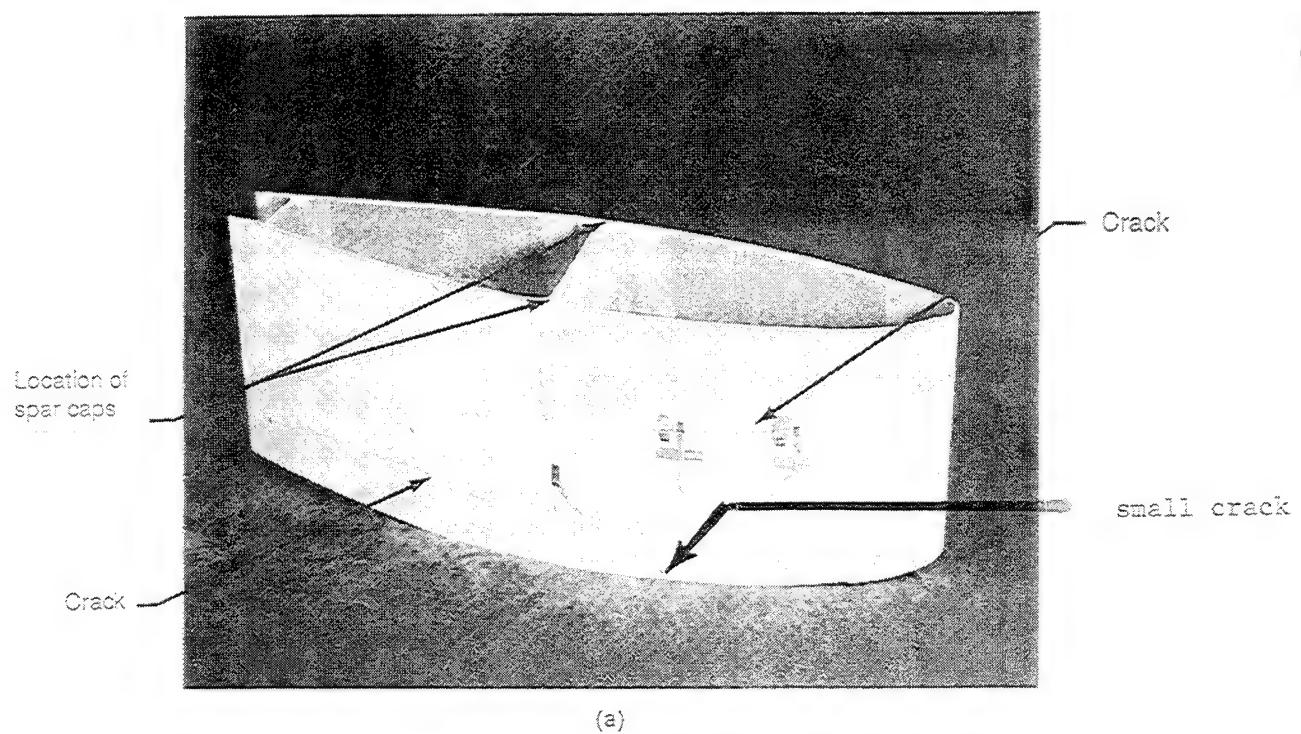
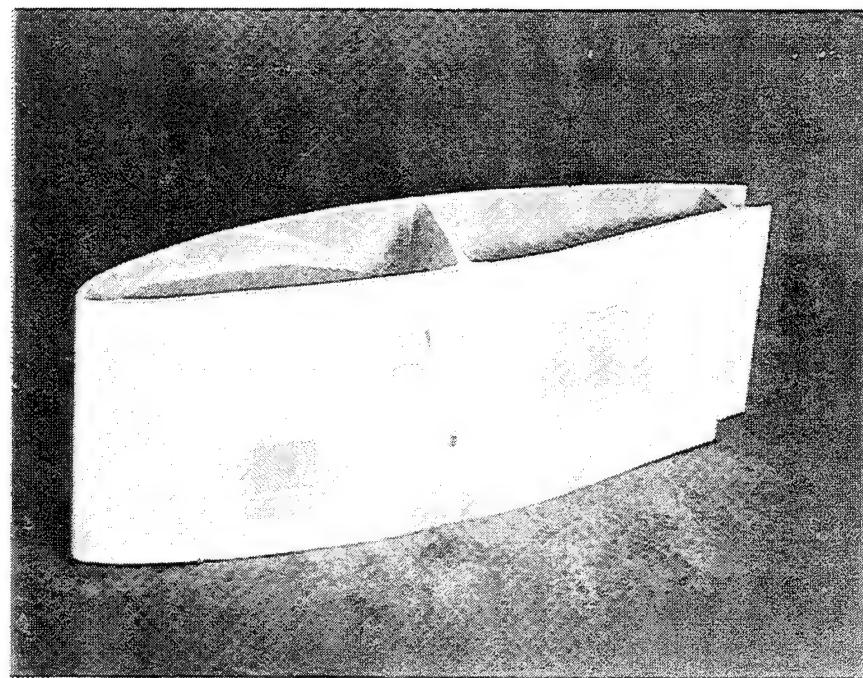
The lower skin, fabricated identically to the upper skin, contained five regions which appeared to be in various stages of repair. Two of the regions (one ~5.5 and the other ~3.0 inch square) were located in the main section of the lower skin. Both contained exposed honeycomb and white potting compound along the perimeter of the exposed regions. In addition, the surfaces adjacent to these two regions were sanded. Another region (~2.0 inch square) simply had the honeycomb removed down to the inner surface skin. Finally, two sanded regions were located on the edge of the lower skin, one at the spar cap and the other aft of the mid-spar. Both of these regions were approximately 2 inch square and had also been sanded through the Gelcoat.

Figure 2. Photographs of the Outer Surfaces of the Wing Section
a) Upper Surface
b) Lower Surface
